# Manhole Inspection Summary

Manhole # S53M\_\_009MH

Insp Date: **7/21/08 2:42 PM**

**Location** Address: **rear 822 s decker st**

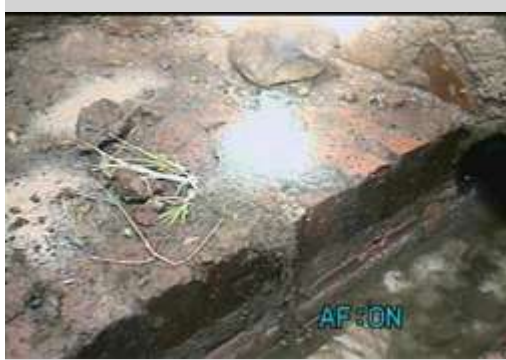
Misc

Condition: ☒ Sound ☐ Cracked ☐ Root Intrusion ☐ Deteriorated ☐ Leaks ☐ Debris

bench debris

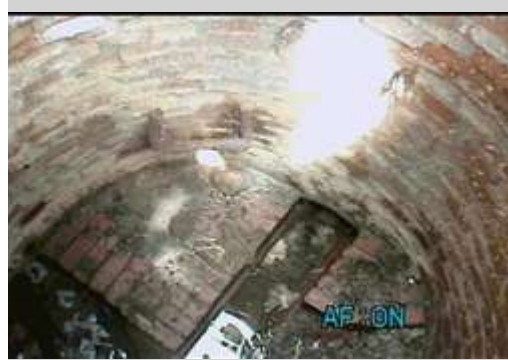
Defect 3

Count: **2** Missing: **1** ☒ **Corroded**

steps missing/corroded

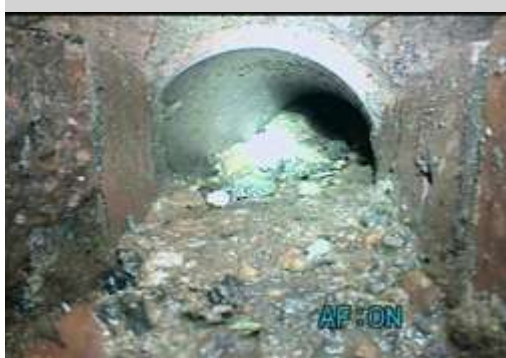
Defect 1

Condition: ☐ Sound ☐ Cracked ☐ Root Intrusion ☐ Deteriorated ☐ Leaks ☒ **Debris**

channel debris

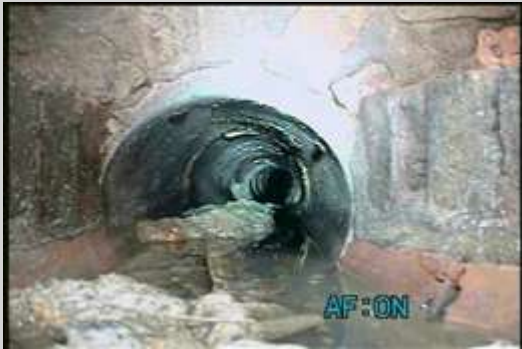
12 O'Clock Outflow

Deposits: ☐ None ☐ Mud ☐ Sludge ☒ **Debris** ☐ Grease

Silt Depth: 2 (in.) Deposits Extent: **Light**

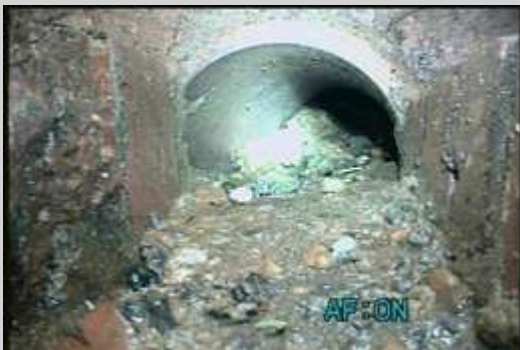
8 O'Clock Inflow

Deposits: ☐ None ☐ Mud ☒ Sludge ☒ Debris ☐ Grease

Silt Depth: 3 (in.) Deposits Extent: **Medium**
